Investigating the effect of retained austenite on wear and fatigue behavior of AISI 8620 steel

DOCTOR OF PHILOSOPHY

Major: Mechanical Engineering

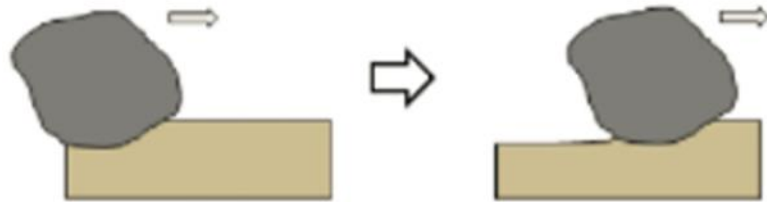
Figure 1.3: Abrasive wear mechanism [41]

Abrasive wear happens when a hard surface slides on a soft surface. The type of contact in case abrasive wear determines whether it is a two-body abrasion or three body abrasion. Figure 1.3 shows the fundamental difference between abrasive and adhesive wear mechanism.

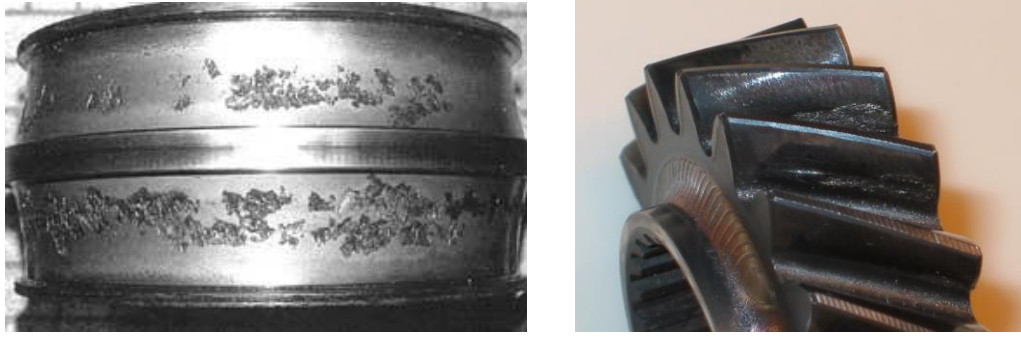
Figure 1.5: Representative images of macropitting phenomena observed in gears (left) [46] and bearings (right) [47]
